# Inspection, Evaluation, and Repair of SPF Roofing Systems after a Windstorm or Hail Event

## BY MASON KNOWLES AND DON BEST

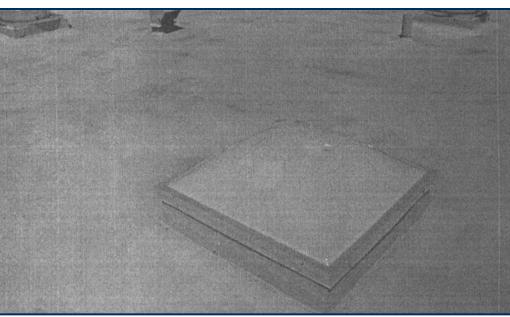
The skylight has been damaged by hail, but the SPF roof exhibits no visible signs of damage.

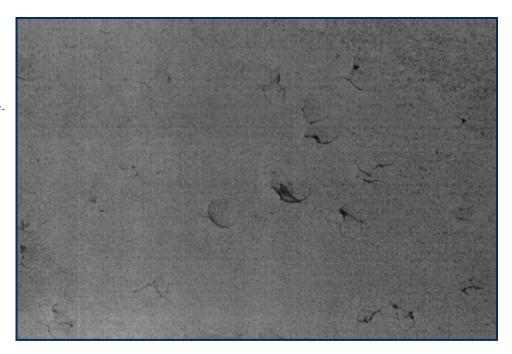
This photo depicts moderate to severe hail damage that would most likely require scarifying the surface, refoaming, and coating. Other factors to consider:

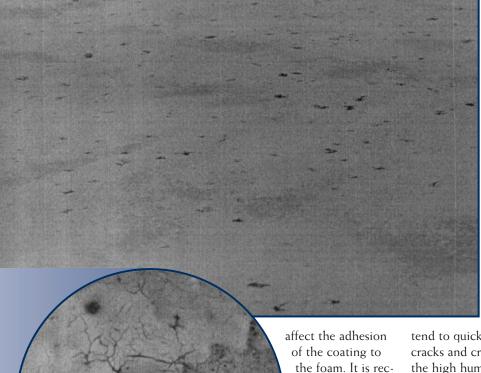
Left: Severe hail damage requiring scarifying of the surface, refoaming, and recoating is pictured.

Inset: This photo shows a severe hail dent over brittle coating. Note the many cracks formed by small hail impact. These cracks have been created by the brittleness of the coating. If not for the cracks, the damaged foam could have been removed from the hail hole, and caulked. Because of the numerous cracks, this roof must be scarified, refoamed, and recoated. (Most likely this coating is very old; most coatings will tend to become brittle with age.)
