**RECOMMENDATIONS FOR REPAIR OF  
SPRAY POLYURETHANE FOAM (SPF) ROOF  
SYSTEMS DUE TO  
HAIL AND WIND DRIVEN DAMAGE**

**RECOMMENDED  
DESIGN CONSIDERATIONS  
AND GUIDE SPECIFICATIONS**

**Spray Polyurethane Foam Alliance  
Copyright January 2003**

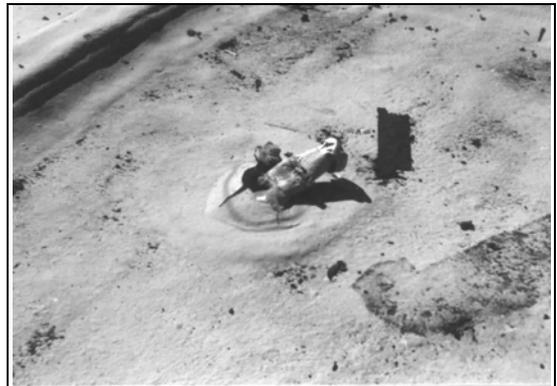
During high wind events a wide variety of objects can potentially impact a roof and produce damage to the protective coating and SPF. This damage may be isolated to small areas of the roof or cover large areas. Substrate and structural damage may or may not have occurred and should be thoroughly investigated. The type of repairs required will depend on the size and severity of

the damage and should be consistent with SPFA's Guideline AY-122, "The Renewal of Spray Polyurethane Foam and Coating Roof Systems."

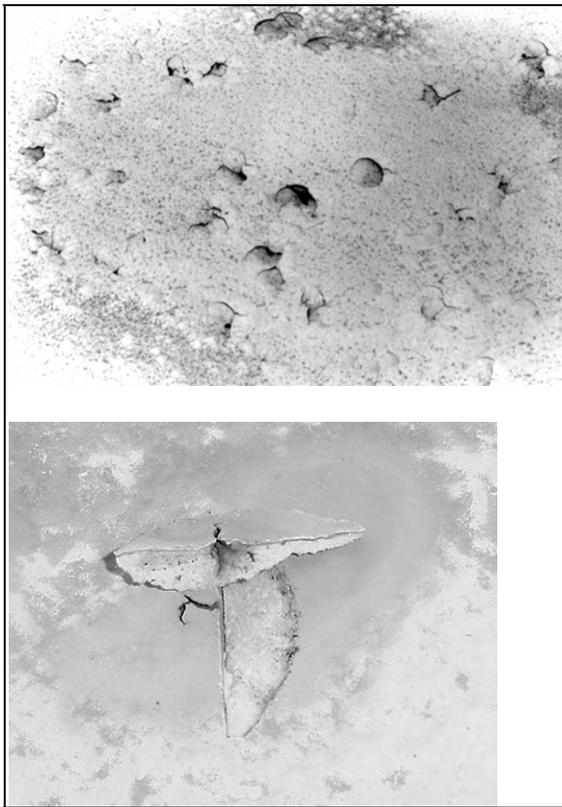
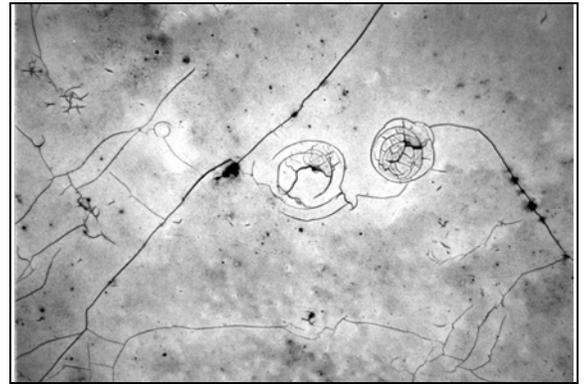
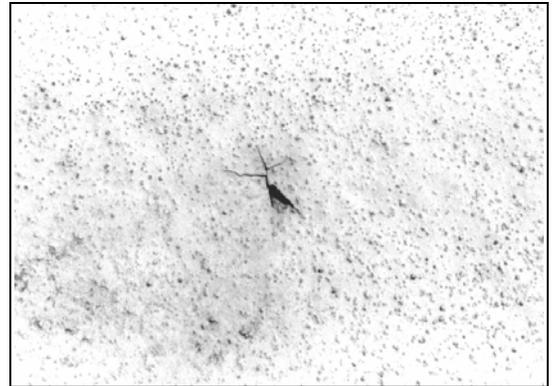
Hail can damage both the surface coating and the underlying foam in an SPF roof system.

Coating damage can appear as gouges, cracks, and punctures. Hail induced coating cracks often form patterns shaped like “crow’s feet” or semi-circles.

Depending on hail stone size, shape, and hardness, the underlying foam may be dented, cracked, or gouged. Depressions in SPF dented by hail stones may be 1/8-inch to 3/4-inch deep. Hail damage can be isolated to small areas or cover the entire roof surface.

The repair technique is determined from the severity (size and depth of damage) and extent (number of hail hits per unit area) of the hail damage. For example, fifteen 3-inch diameter hail dents on a 1000 square foot roof may be easier to repair than hundreds of 3/4-inch diameter dents.
