# Inspection, Evaluation, and Repair of SPF Roofing Systems after a Windstorm or Hail Event

## BY MASON KNOWLES AND DON BEST

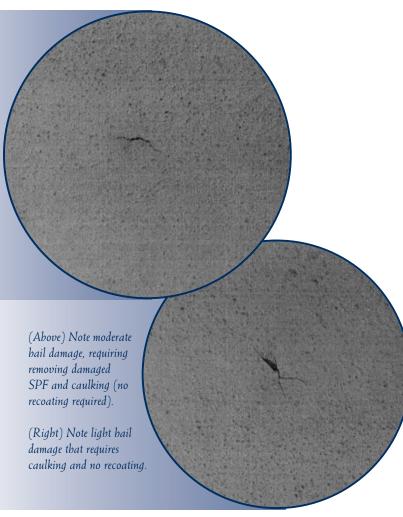
This photo depicts moderate to severe hail damage that would most likely require scarifying the surface, refoaming, and coating. Other factors to consider:
