Hail and SPF Roofing

SPF (spray polyurethane foam) roofing systems have exceptional characteristics. They offer great insulation, are resistant to high winds, protect the substrate against damage from hail and wind driven missiles, and can be recoated to extend its life. Frequently, however, some in the roof industry have poor perceptions of how SPF roofing systems perform in hail events. For many years the conventional roofing market perceived SPF roofing as soft and easily damaged calling the system PUF.

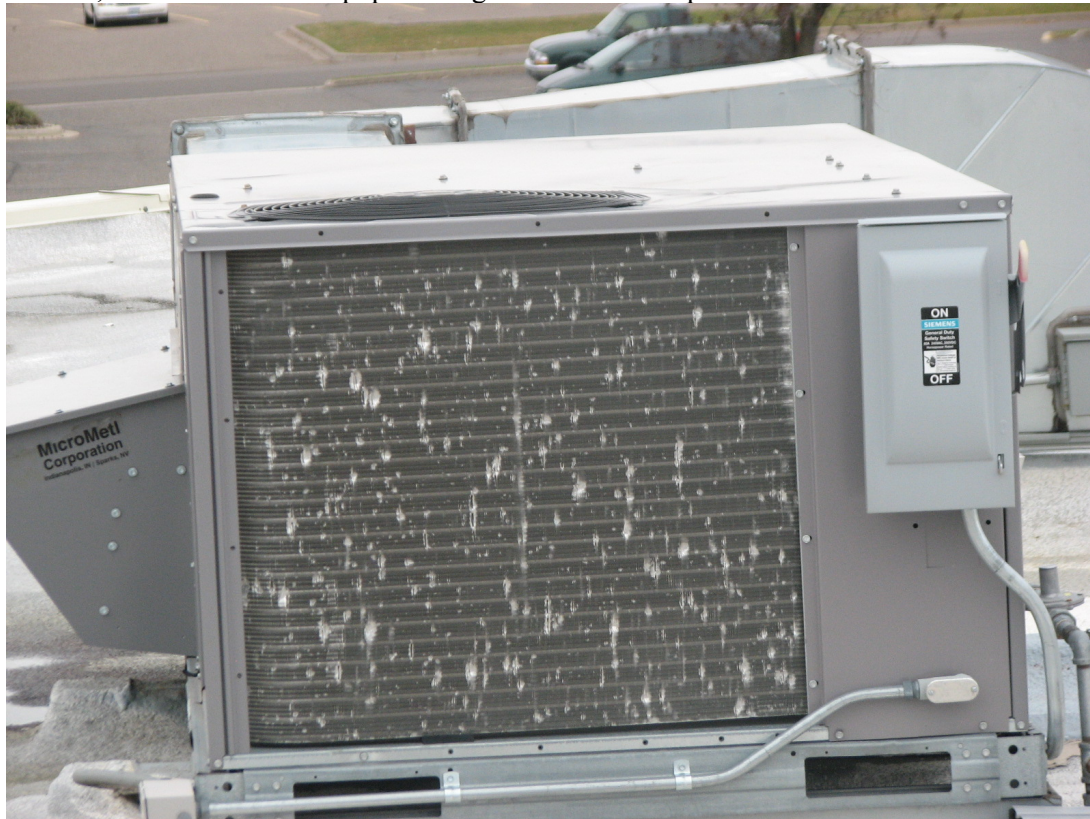
Photo 1, Dents on HVAC equipment signal that a hail inspection should be conducted

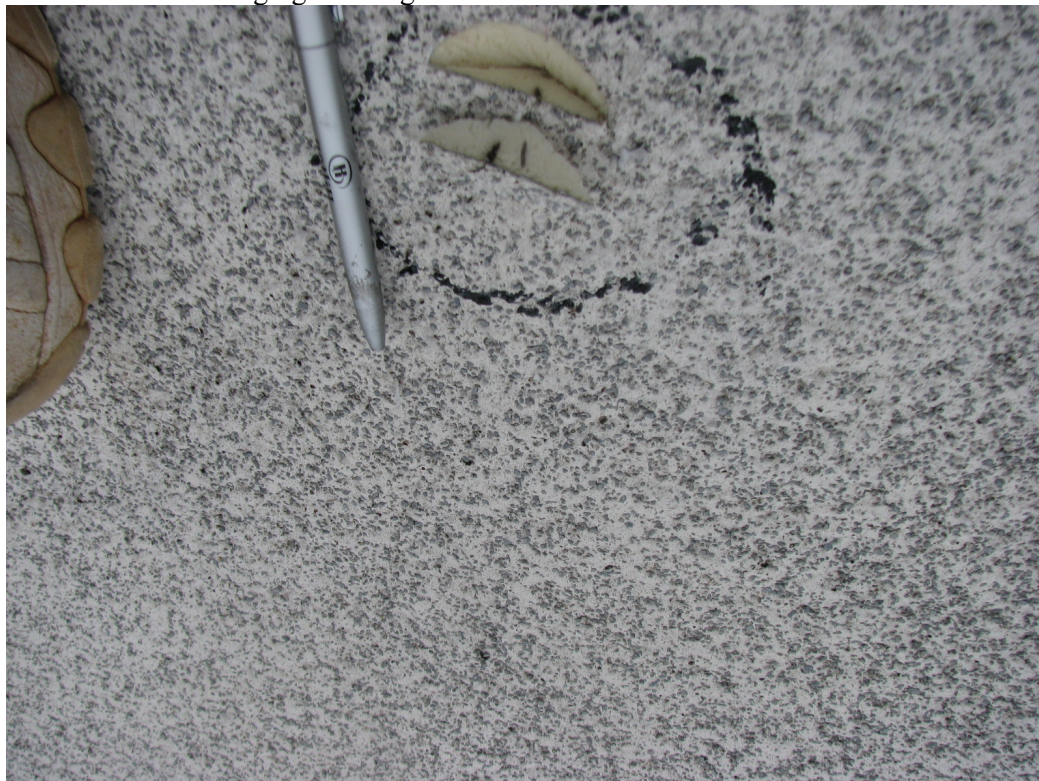
Photo 2 Slit samples can show the severity of damage from hail impact. The crack in this sample is less than 1/4 inch indicating light damage

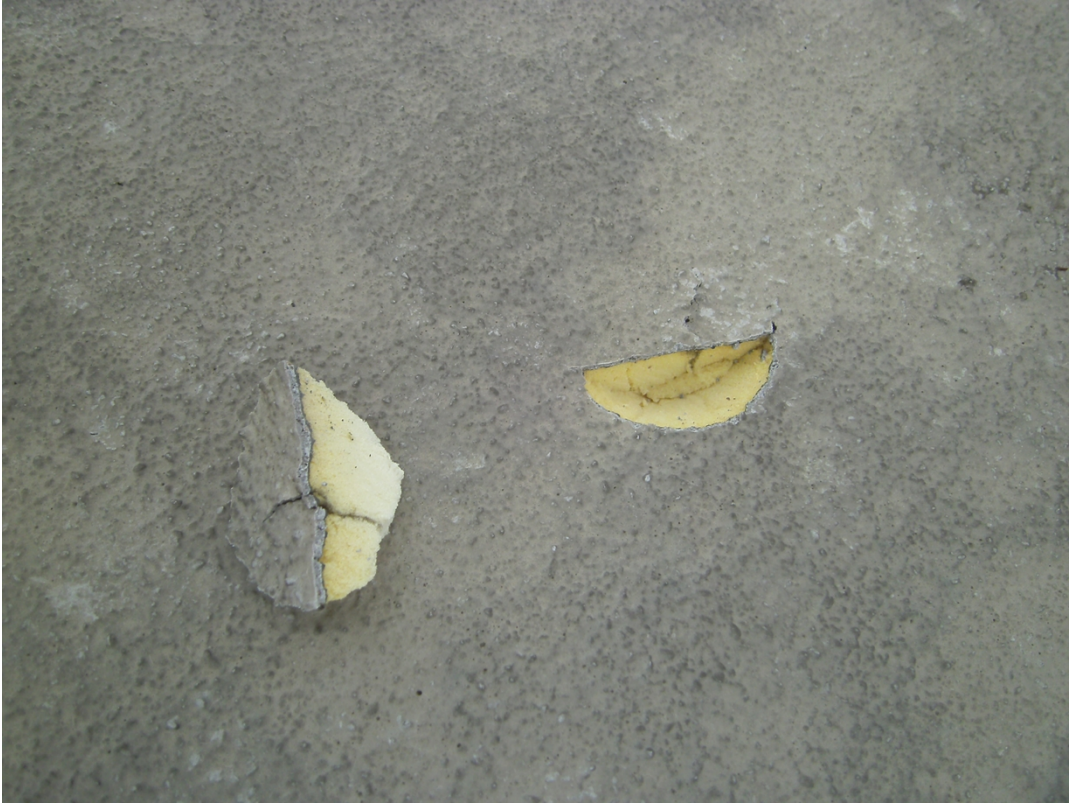
Photo 3 This crack extends 3/4 inch into the foam and showing the hail damage is more severe

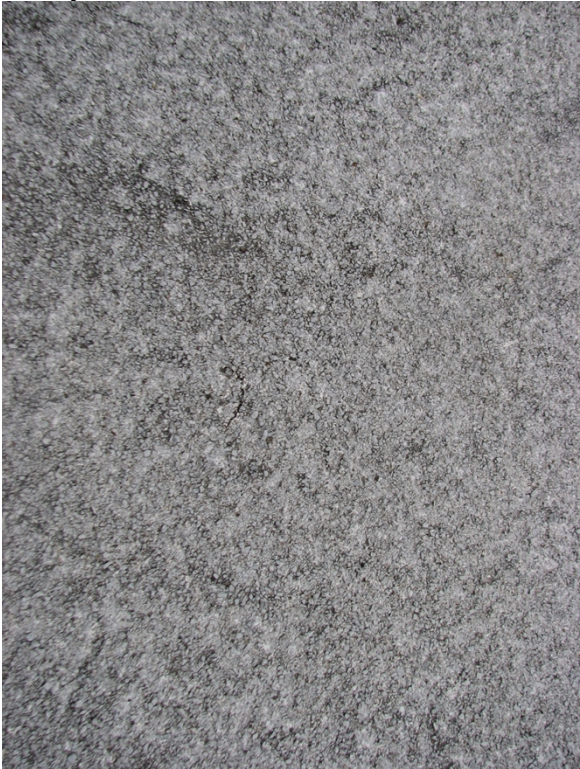
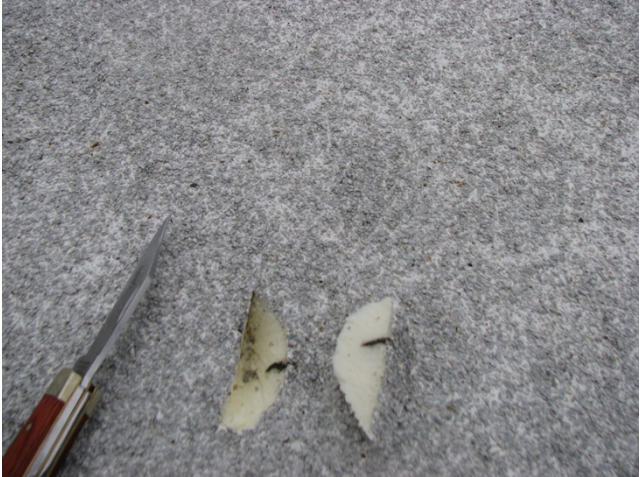
Photos 4 & 5 Granules can help reduce hail damage, but can also hide cracks unless investigated more closely

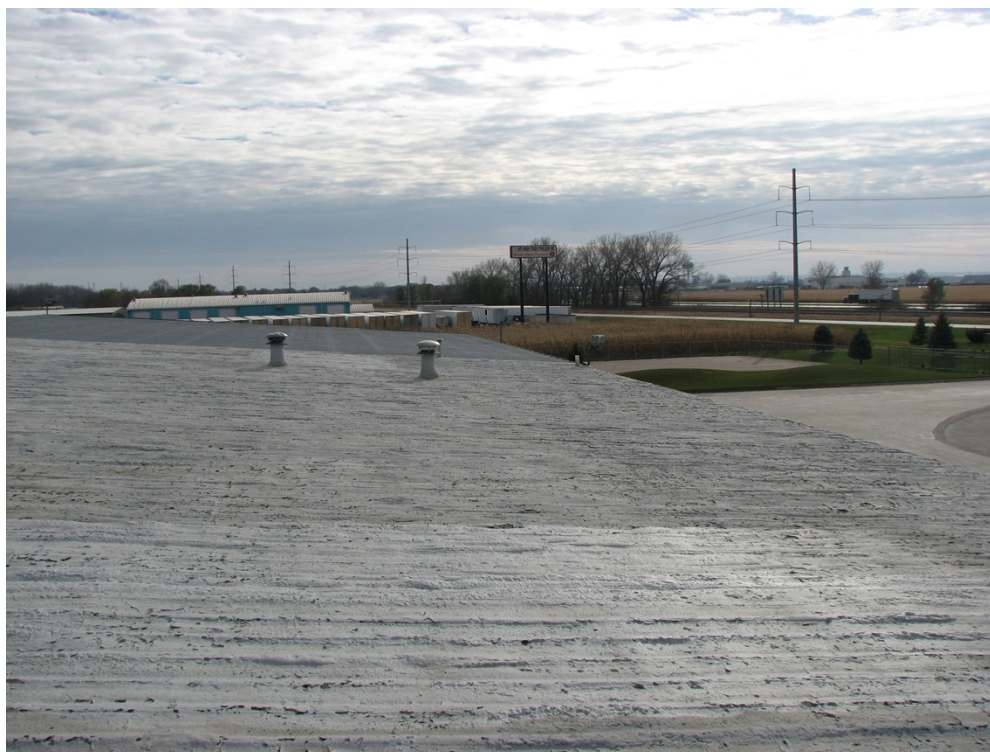
Photo 7 This SPF roof in the northern Midwest was damaged by hail and not recoated for several years. Consequently the roof became saturated.

In cooler temperatures the greater concern of hail damaged roofs is moisture saturating into the SPF. There may be long periods of time where drying conditions do not occur. In many areas snow may stay on the roof for extended periods increasing the possibility of moisture saturation. It is important to repair crushed foam and coating cracks as soon as possible to prevent moisture saturation of the damaged areas.
