SPRAY FOAM Insulation & Termites

This document addresses questions pertaining to inspection for, and treatment of, potential termite infestations in buildings using SPF insulation. It provides basic information about termite identification, inspection and treatments methods as well as discusses the importance of air-sealing and insulation of critical areas using SPF. It also presents code-compliant solutions to address these concerns.

Spray Foam Insulation & Termites

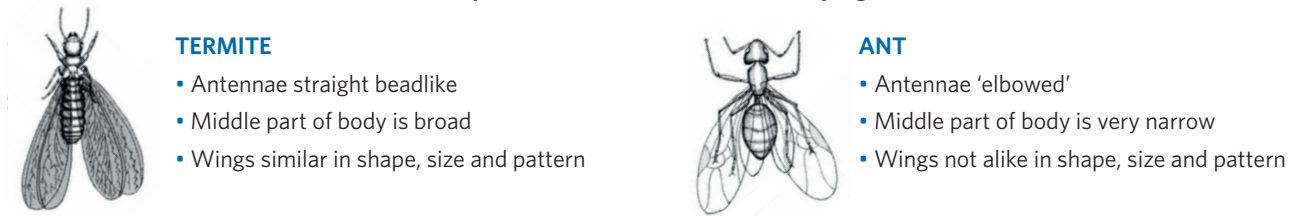
FIGURE 1. Comparative differences between flying ants and termites

Termites are insects that are often hard to spot and identify. To the untrained eye, flying ants can be easily mistaken for swarming (alate) termites. Figure 1 shows a comparative diagram of flying ants and termites.

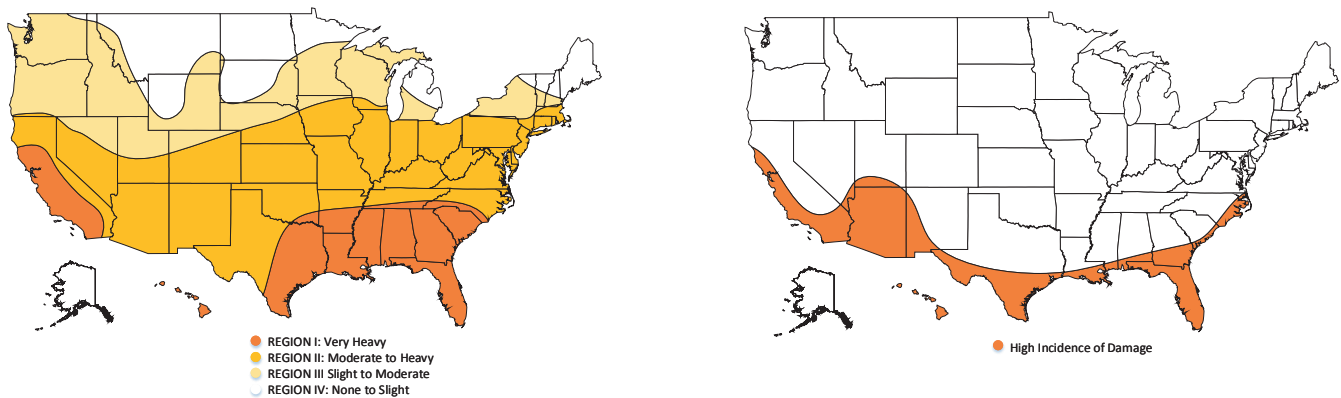
FIGURE 2. Probability of Termite Infestation for the US

Subterranean Termites – Are the most common type of termite. They build nests underground to maintain moisture levels in the colony. They use protective mud tunnels from the nest to the food source.

Drywood Termites – Can create colonies in wood with no connection to the ground. These termites need little water to survive. Infestations, often found in attics, typically identified by frass pellets.

Formosan Termites – A type of subterranean termite that build nests within the soil. They can also create nests that retain moisture, thus no longer needing contact with the ground (mud tubes).

Termites voraciously consume cellulose, meaning that any plant-based material can be a source of food – including leaves, compost, wood piles, and of greatest concern, wood components and furnishings of a home. While there are many (45-50) species of termites in the US, only about 20 are known to destroy wood structuresⁱⁱ. Figure 2 shows the probability of termite infestation (by type) across the entire US.

For residential construction, the International Residential Code (IRC)^{ix} specifically addresses subterranean termite control methods in Section R318 during new construction, and measures depend upon the building location on the map in Figure 2. The requirement for preservative-treated or naturally durable termite resistant wood are also identified as termite control strategies are identified in the International Building Code (IBC), Section 2304.12 for commercial buildings.

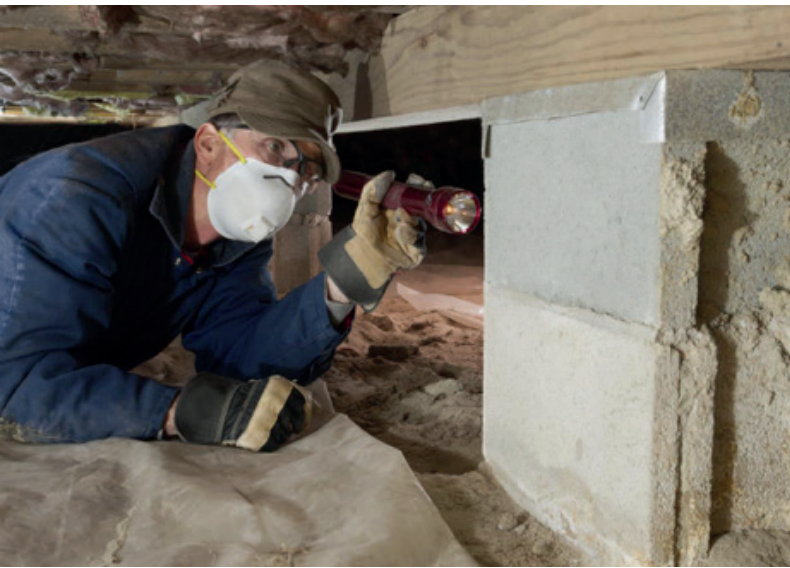
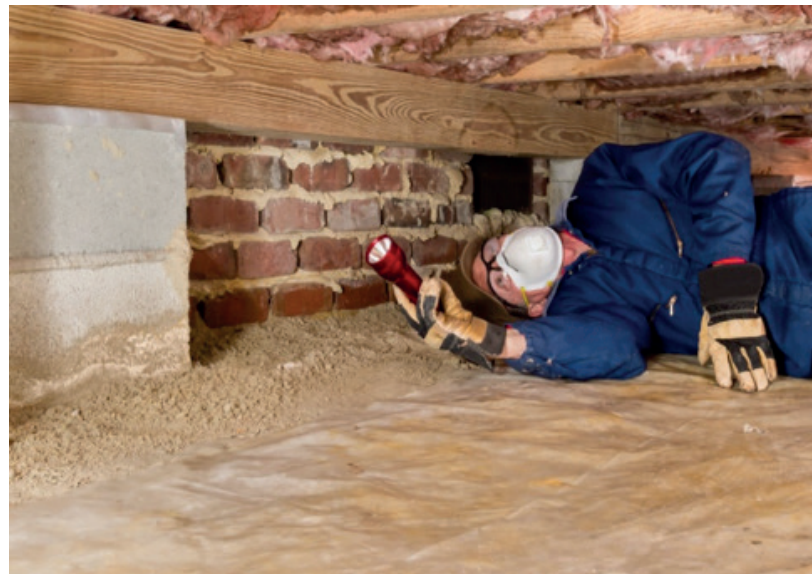
FIGURE 3. Visual termite inspection

The most common method to determine if termites are present in a building is by visual inspection. In a traditional visual termite inspection, a trained professional will inspect areas of the structure where termites typically enter the building and feed upon the structure (Figure 3).

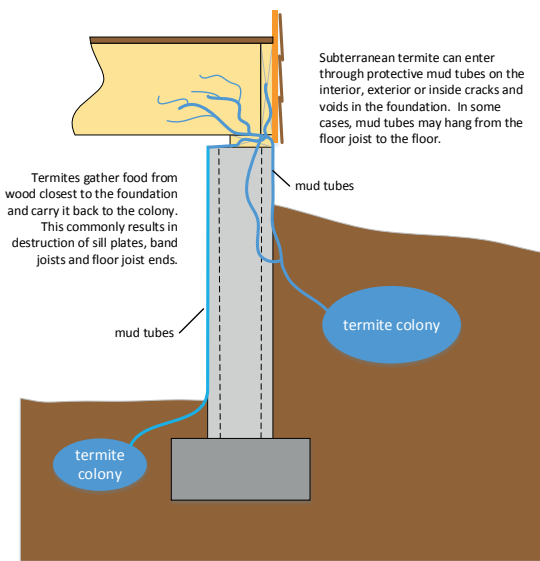
FIGURE 4. Inspection areas and evidence of subterranean termites (mud tubes)

Trained personnel generally inspect areas where termite infestation is likely to occur, looking for the onset of wood damage. For subterranean termites, this includes inspection of areas where the foundation meets the framing. Termite inspectors typically look for mud tubes from subterranean termites that serve as protected pathways between the underground colony and the nearby food source. Examples of mud tubes are shown in Figure 4. Inspectors also look for early damage to framing in contact with or near the foundation (sill plates, band/rim joists and floor joists). Examples of termite damage are shown in Figure 5. For drywood termites, inspectors look for frass (excrement), as well as small bore holes.

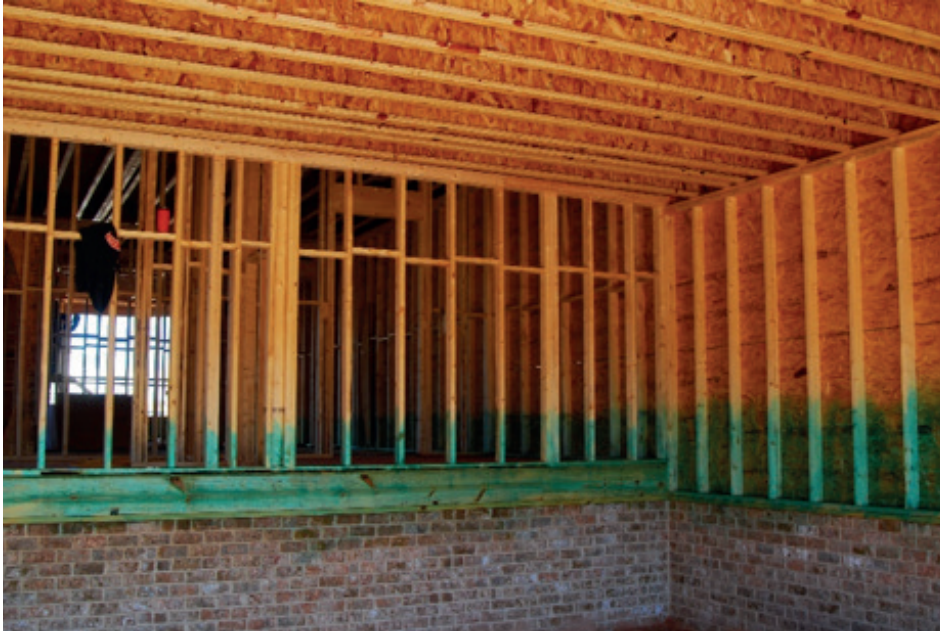
FIGURE 6. Borate treatment of select structural wood components

- Borate treatment of select wood members (Figure 6)
- Termiticide application on the surrounding ground areas (Figure 7)
- Termite baiting systems (Figure 8)
- Use of preservative treated wood or termite resistant wood (Figure 9)*
- Physical barriers (sheet metal or wire mesh) between foundation and framing (Figure 10)
- In areas of very heavy termite infestation:
 - o The use of foam plastic insulation is *not permitted* on the exterior face of walls, or below footings, foundations or slabs that are below grade.
 - o Foam plastic on above grade walls must be 6" above the ground.

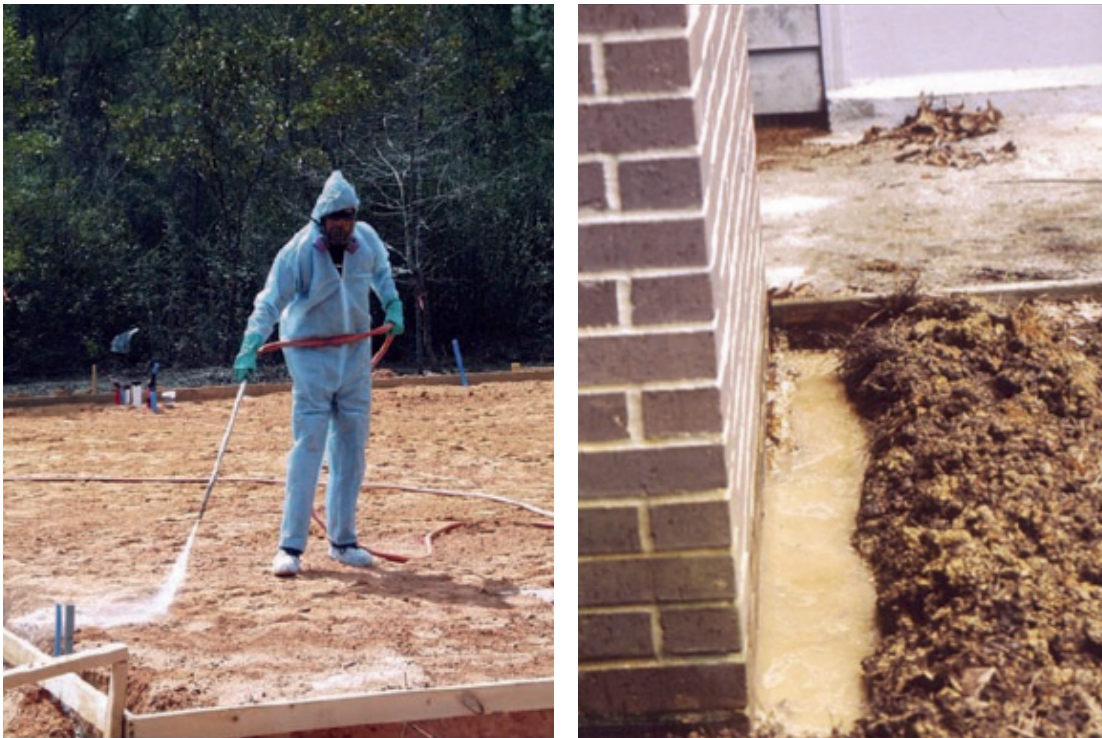
FIGURE 7. Termiticide treatment of the ground below slab and near the foundation

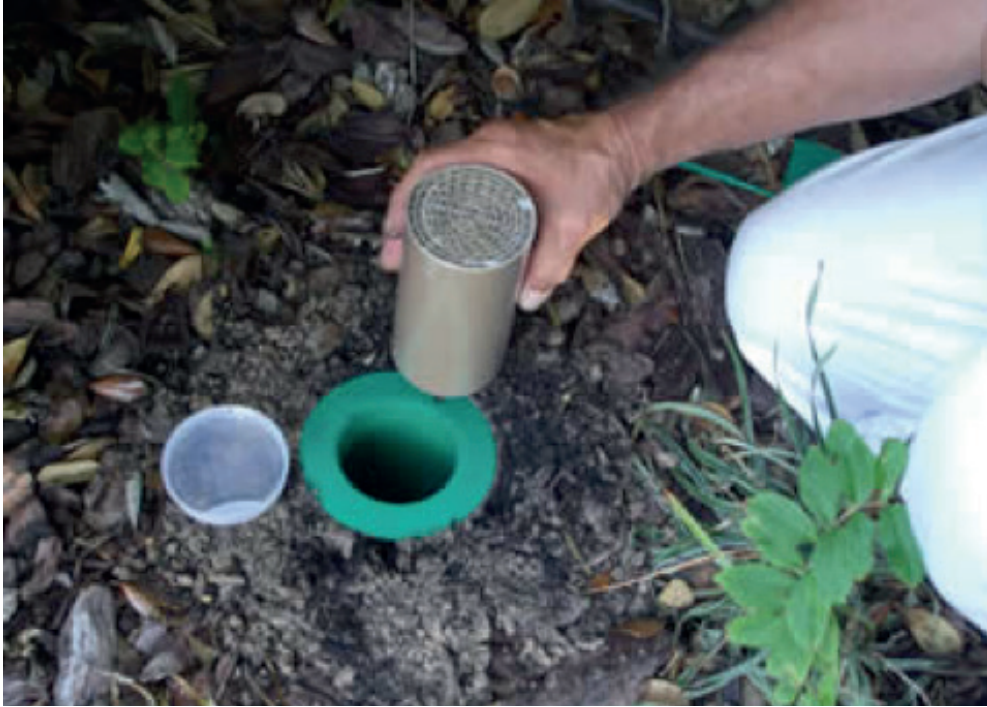
FIGURE 8. Termite baiting systems

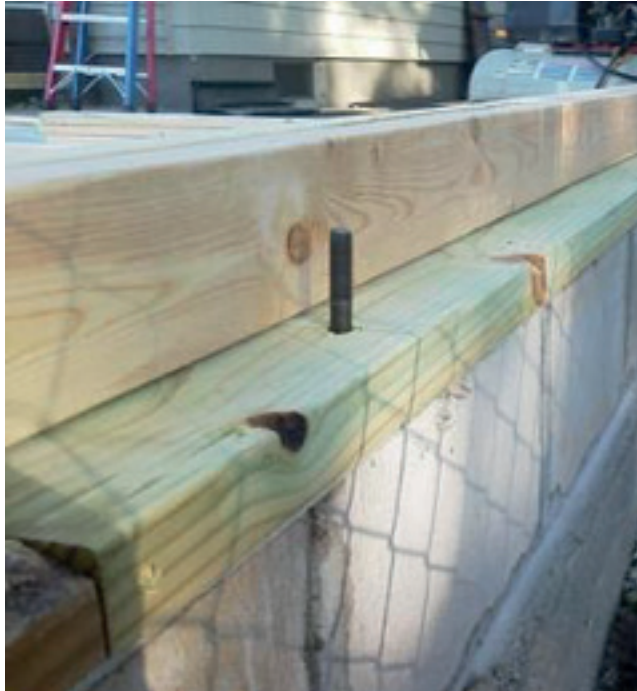
FIGURE 9. Termite resistant wood near the foundation

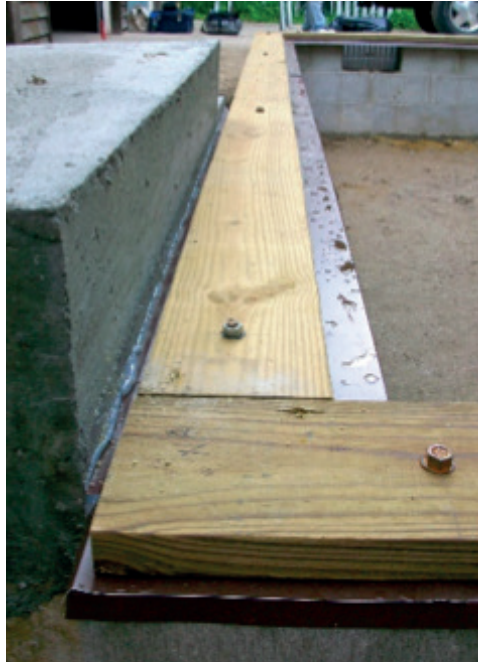
FIGURE 10. Physical termite barriers and shields

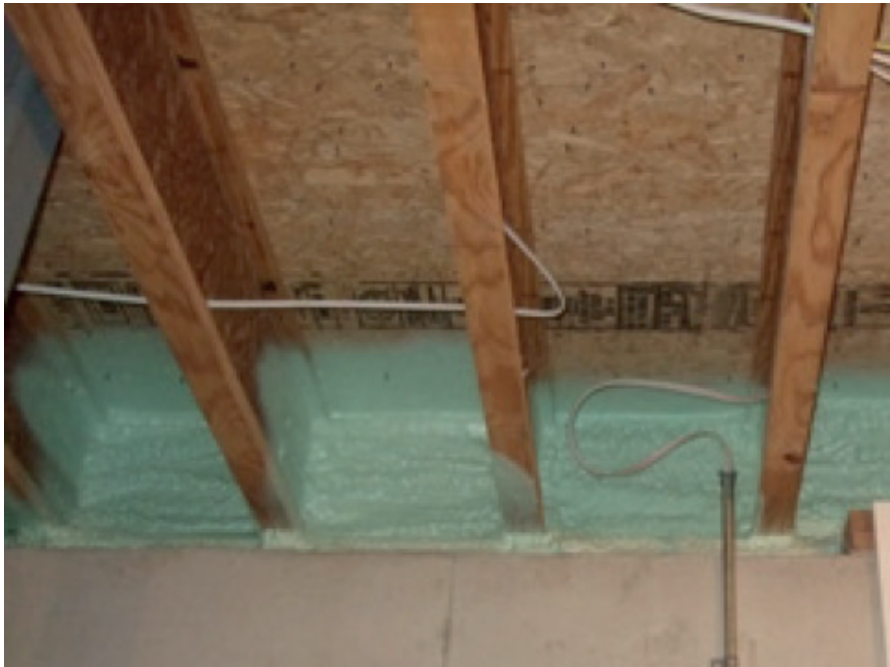
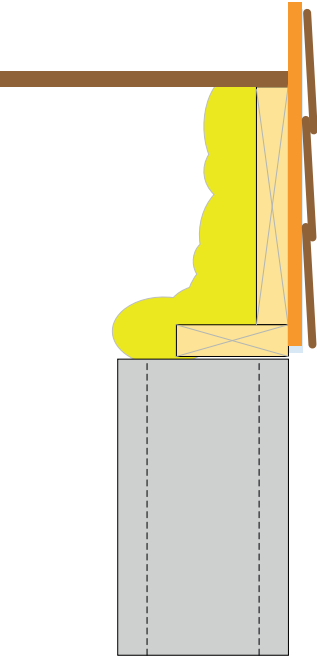
FIGURE 12. Closed-cell SPF insulation at the foundation-framing area

SPF is often used by builders of new homes and weatherization contractors in existing homes at the framing-foundation area, and is often regarded as an especially cost-effective and reliable means to insulate and air seal these critical areas⁸. Figure 12 shows the installation of closed-cell SPF from beneath the subfloor to the top of the foundation, providing long-lasting insulation, air sealing, and moisture control.

The concern by some pest control and inspection companies with these permanent applications of foam plastic in the rim joist, shown in Figures 12 and 13, is that it does not permit removal of the insulation for traditional visual inspection of the sill plate, band/rim joists or the ends of the floor joists. This challenge can be addressed through use of newer technologies when inspecting for termites.

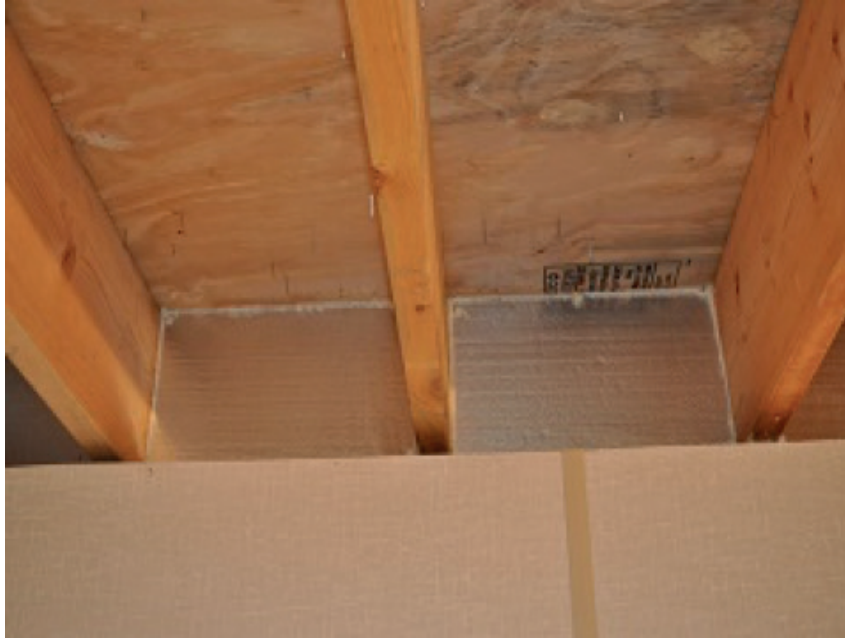
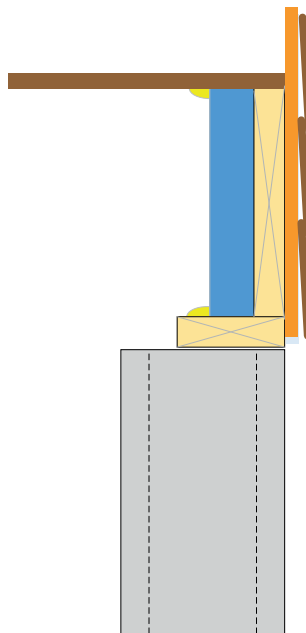
FIGURE 13. Foam board insulation and sealant/caulk at the foundation-framing area

Alternative methods of insulating these areas may include the use of cut foam insulation board perimeter sealed with caulk or polyurethane foam sealant, as shown in Figure 13. This approach, is used by some weatherization contractors. It is generally more labor intensive than SPF application, as it requires cutting of the foam board followed by the application of a caulk or sealant. It can be especially difficult application in tight areas and will require cutting around engineered wood I-joists. Like SPF, this application provides long-lasting insulation, air sealing and moisture control. Note that this method does not always provide sealing of the gap between the sill plate and foundation.

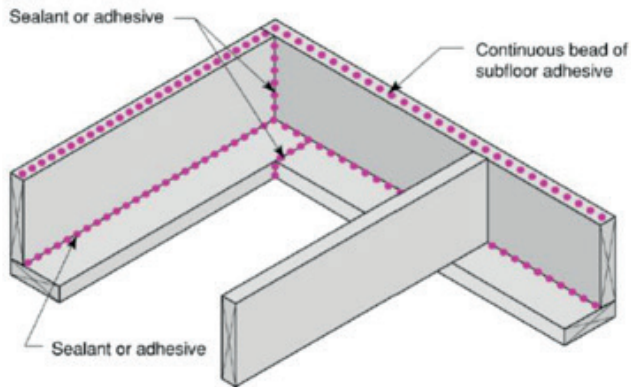
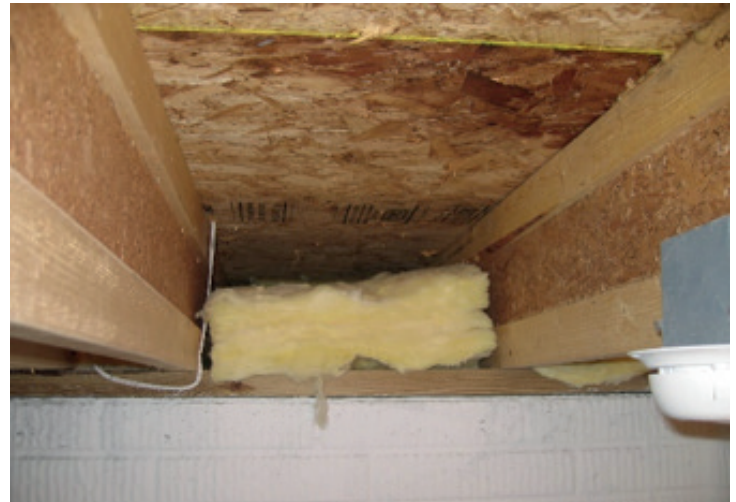
FIGURE 14. Sealing and insulating the band joist with fiberglass batts (improperly re-installed)

Another means of insulating and air sealing of the framing near the foundation involves application of a caulk or sealant around the perimeter of each cavity, followed by installation of insulation batts, as shown in Figure 14. Like the use of foam board insulation, it requires a labor-intensive caulking or sealing. It should be noted that unlike SPF and boardstock, this is not a permanent installation.

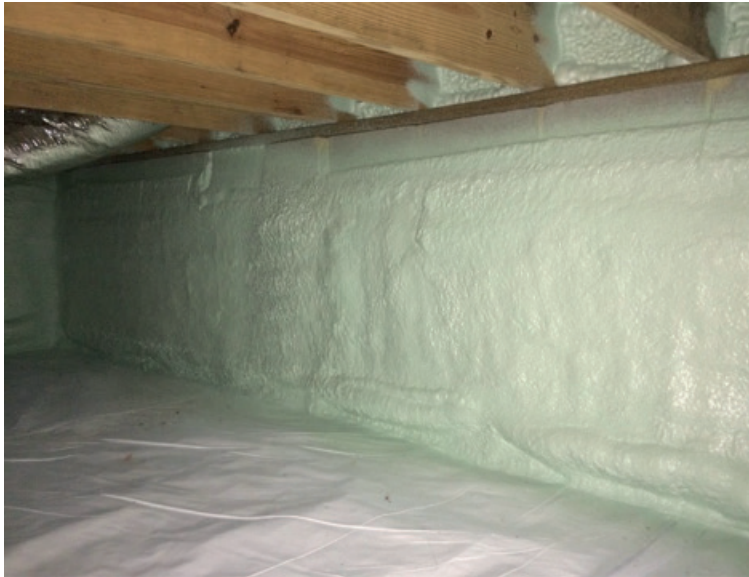
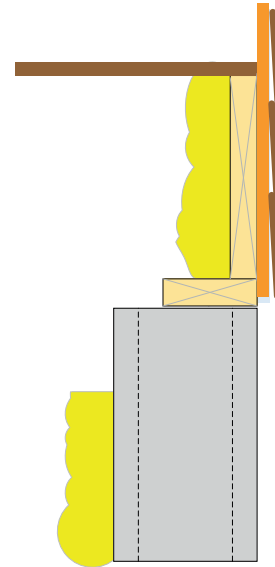
FIGURE 16. Installation of SPF to provide termite inspection strip

In addition, some states including North Carolina^{xi}, Georgia^{xii} and Alabama^{xiii} have modified the model code to include a termite inspection strip above and below the top of the foundation wall to expose the sill plate and lower band/rim joist for visual inspection. SPF can be installed in this manner to meet these state-specific codes, as shown in Figure 16.

It should be noted that the SPF installation of Figure 16, while sealing some air leakage paths and meeting certain code requirements for termite inspection strips, does not seal the path between the sill plate and foundation, and caulking may be needed at this location to enhance the air leakage resistance of the sill sealer.

As an alternative to encapsulated or conditioned crawlspaces, with the interior of the stem walls covered in foam as shown in Figure 16, SPF can be applied directly below the subfloor and leaving the crawlspace vented. This installation is shown in Figure 17. While this application will typically require more insulation than a conditioned crawlspace, it enables complete access to the band joist and sill plate areas for termite inspections. Application of SPF to the subfloor will help provide air sealing and insulation of the floor assembly, but can limit access to wiring and plumbing. Insulation may need to be added to ductwork and piping located in the vented, unconditioned crawlspaces. Additionally, a vapor retarder may be needed between the SPF and vented crawlspace to help control moisture condensation in hot-humid climates if open-cell SPF is used.

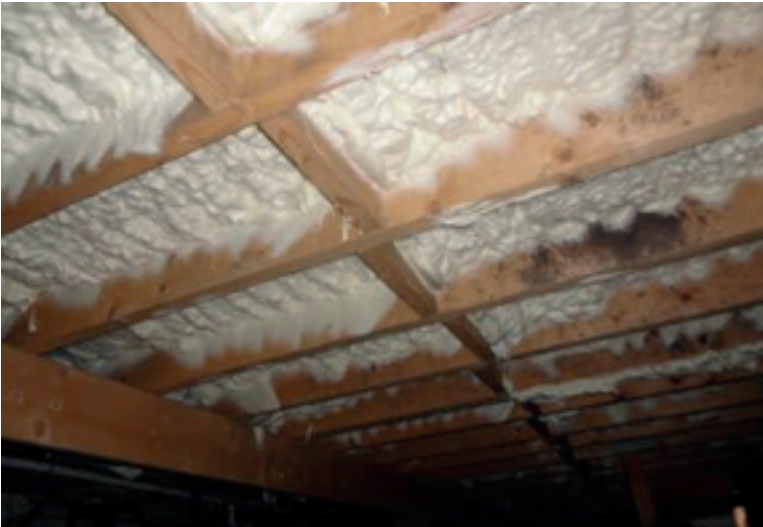
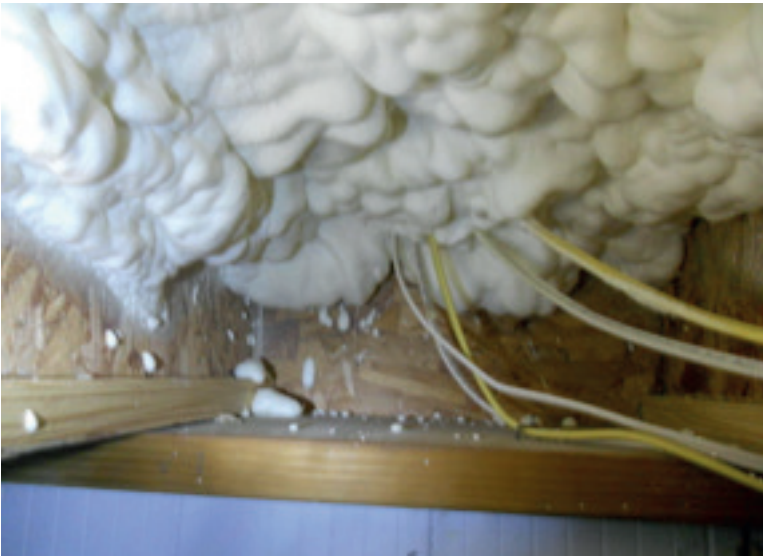
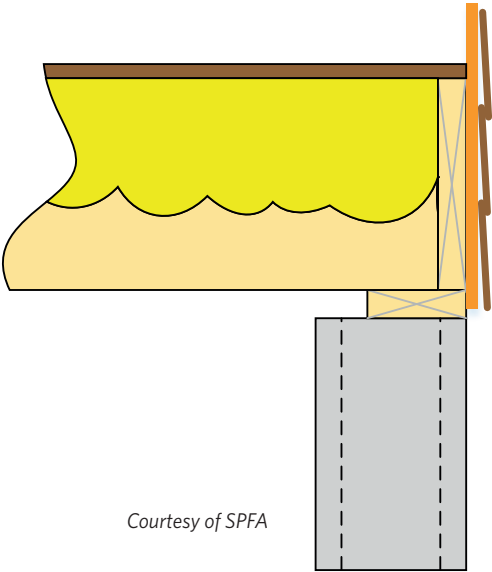
FIGURE 17. Installation of SPF below the subfloor allows complete access to the band joist and sill plate for inspection.
