# SPRAY FOAM Insulation & Termites

This document addresses questions pertaining to inspection for, and treatment of, potential termite infestations in buildings using SPF insulation. It provides basic information about termite identification, inspection and treatments methods as well as discusses the importance of air-sealing and insulation of critical areas using SPF. It also presents code-compliant solutions to address these concerns.

## Spray Foam Insulation & Termites

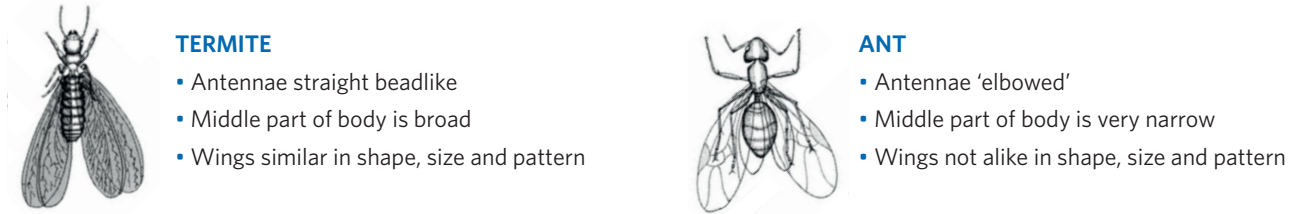
**FIGURE 1. Comparative differences between flying ants and termites**

Termites are insects that are often hard to spot and identify. To the untrained eye, flying ants can be easily mistaken for swarming (alate) termites. Figure 1 shows a comparative diagram of flying ants and termites.

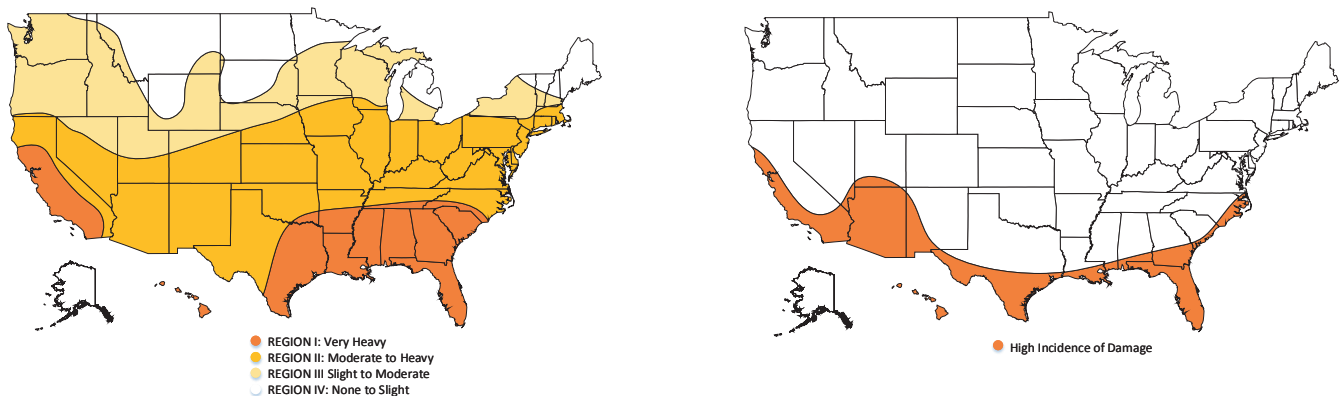
**FIGURE 2. Probability of Termite Infestation for the US**

Termites voraciously consume cellulose, meaning that any plant-based material can be a source of food – including leaves, compost, wood piles, and of greatest concern, wood components and furnishings of a home. While there are many (45-50) species of termites in the US, only about 20 are known to destroy wood structures<sup>ii</sup>. Figure 2 shows the probability of termite infestation (by type) across the entire US.

For residential construction, the International Residential Code (IRC)<sup>ix</sup> specifically addresses subterranean termite control methods in Section R318 during new construction, and measures depend upon the building location on the map in Figure 2. The requirement for preservative-treated or naturally durable termite resistant wood are also identified as termite control strategies are identified in the International Building Code (IBC), Section 2304.12 for commercial buildings.

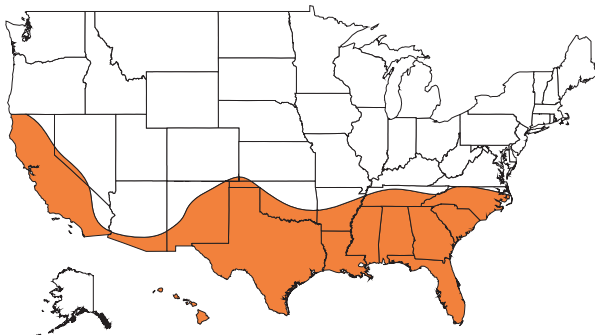
**Subterranean Termites** – Are the most common type of termite. They build nests underground to maintain moisture levels in the colony. They use protective mud tunnels from the nest to the food source.

**Drywood Termites** – Can create colonies in wood with no connection to the ground. These termites need little water to survive. Infestations, often found in attics, typically identified by frass pellets.

**Formosan Termites** – A type of subterranean termite that build nests within the soil. They can also create nests that retain moisture, thus no longer needing contact with the ground (mud tubes).

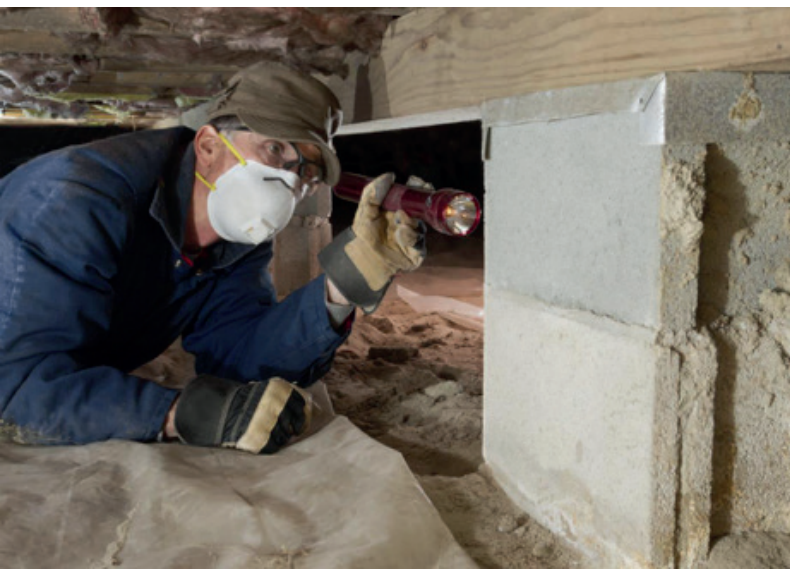
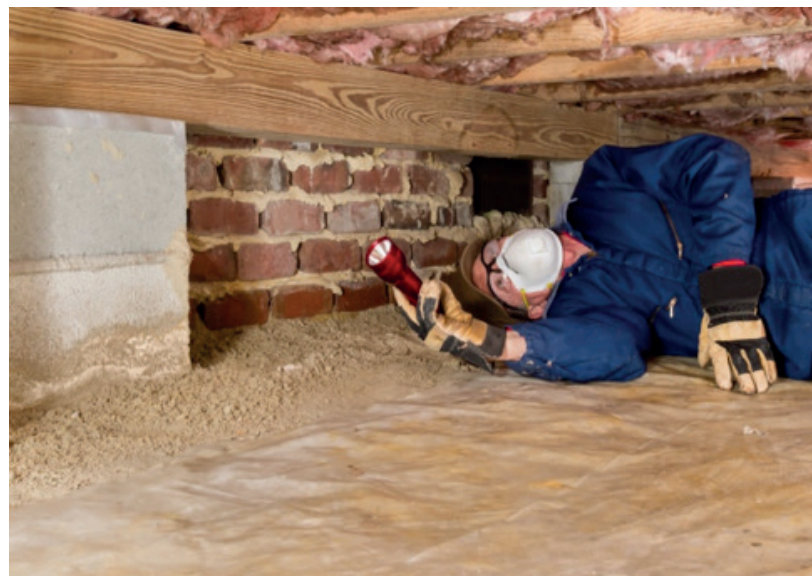
**FIGURE 3. Visual termite inspection**

The most common method to determine if termites are present in a building is by visual inspection. In a traditional visual termite inspection, a trained professional will inspect areas of the structure where termites typically enter the building and feed upon the structure (Figure 3).

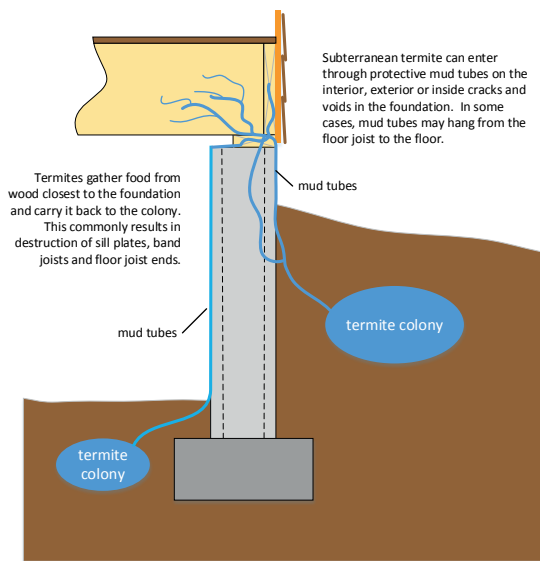
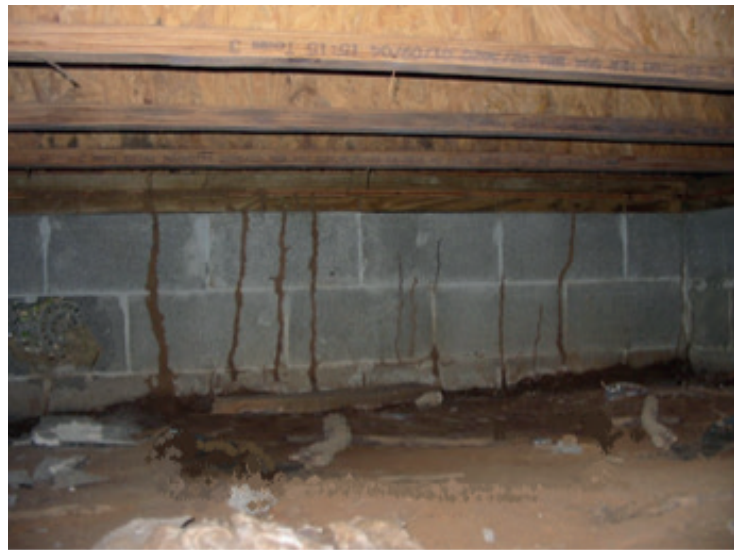
**FIGURE 4. Inspection areas and evidence of subterranean termites (mud tubes)**

Trained personnel generally inspect areas where termite infestation is likely to occur, looking for the onset of wood damage. For subterranean termites, this includes inspection of areas where the foundation meets the framing. Termite inspectors typically look for mud tubes from subterranean termites that serve as protected pathways between the underground colony and the nearby food source. Examples of mud tubes are shown in Figure 4. Inspectors also look for early damage to framing in contact with or near the foundation (sill plates, band/rim joists and floor joists). Examples of termite damage are shown in Figure 5. For drywood termites, inspectors look for frass (excrement), as well as small bore holes.

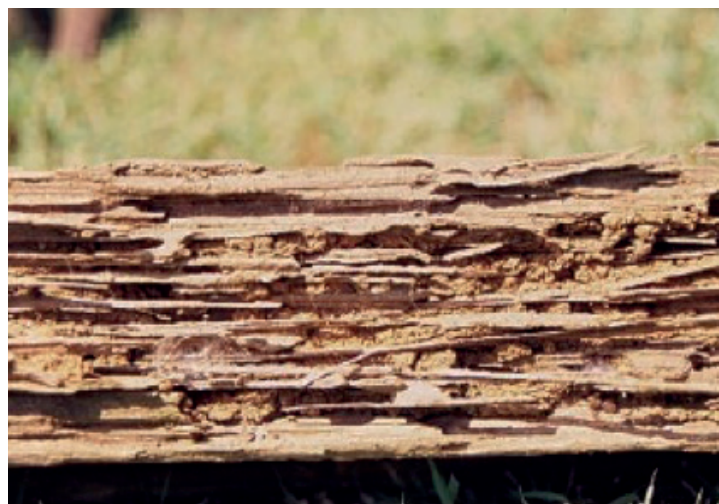
**FIGURE 5. Evidence of structural termite damage**

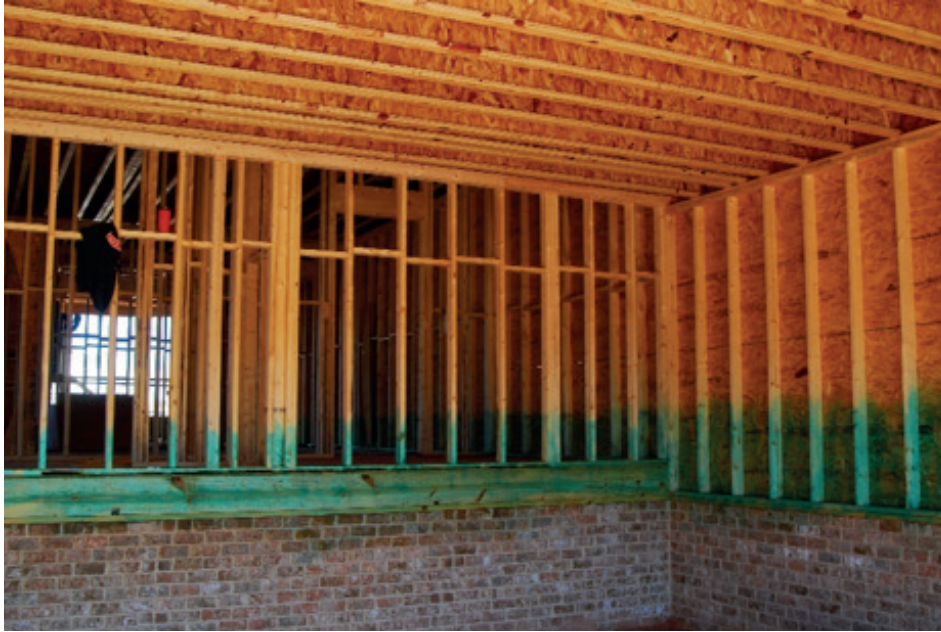
**FIGURE 6.** Borate treatment of select structural wood components

- Borate treatment of select wood members (Figure 6)
- Termiticide application on the surrounding ground areas (Figure 7)
- Termite baiting systems (Figure 8)
- Use of preservative treated wood or termite resistant wood (Figure 9)\*
- Physical barriers (sheet metal or wire mesh) between foundation and framing (Figure 10)
- In areas of very heavy termite infestation:
  - o The use of foam plastic insulation is *not permitted* on the exterior face of walls, or below footings, foundations or slabs that are below grade.
  - o Foam plastic on above grade walls must be 6" above the ground.

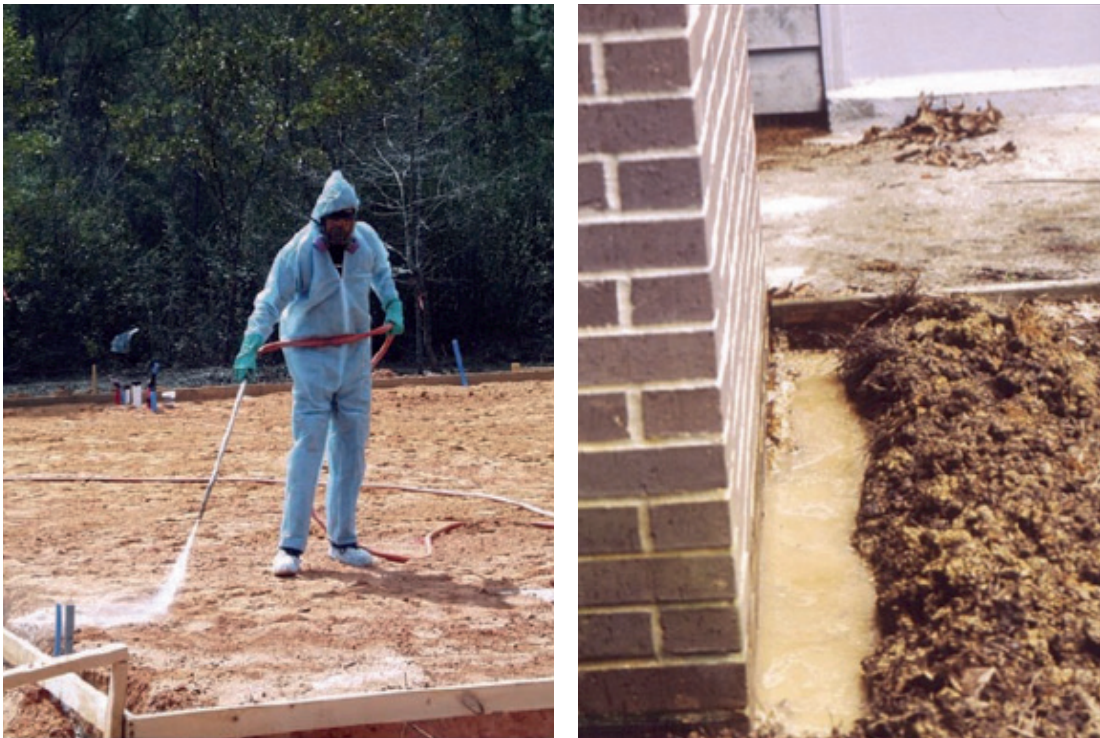
**FIGURE 7.** Termiticide treatment of the ground below slab and near the foundation

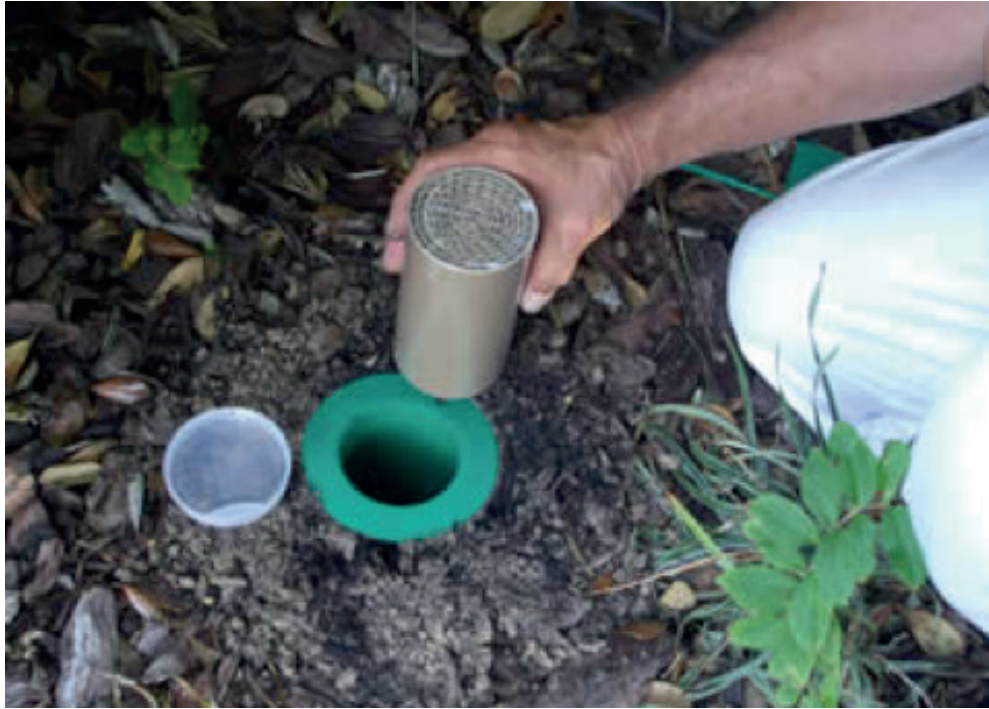
**FIGURE 8.** Termite baiting systems

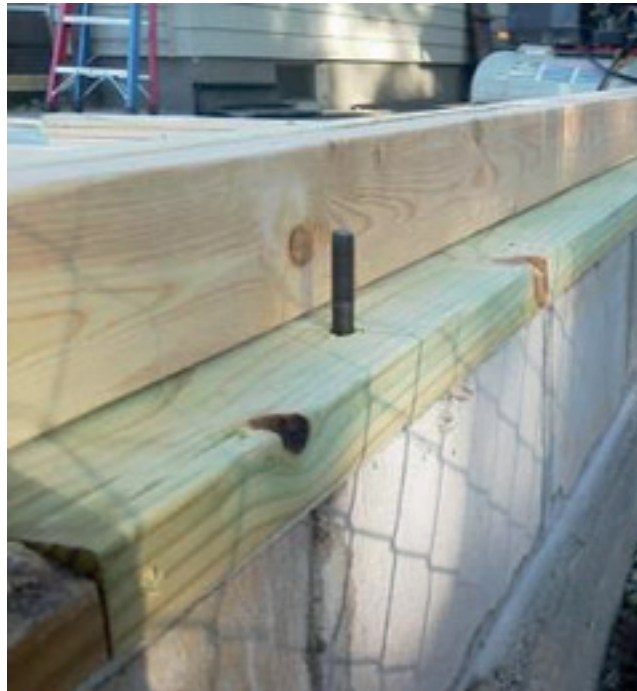
**FIGURE 9.** Termite resistant wood near the foundation

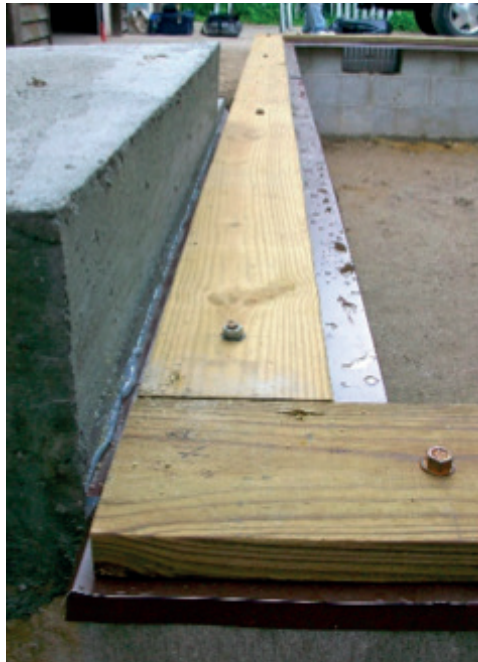
**FIGURE 10.** Physical termite barriers and shields

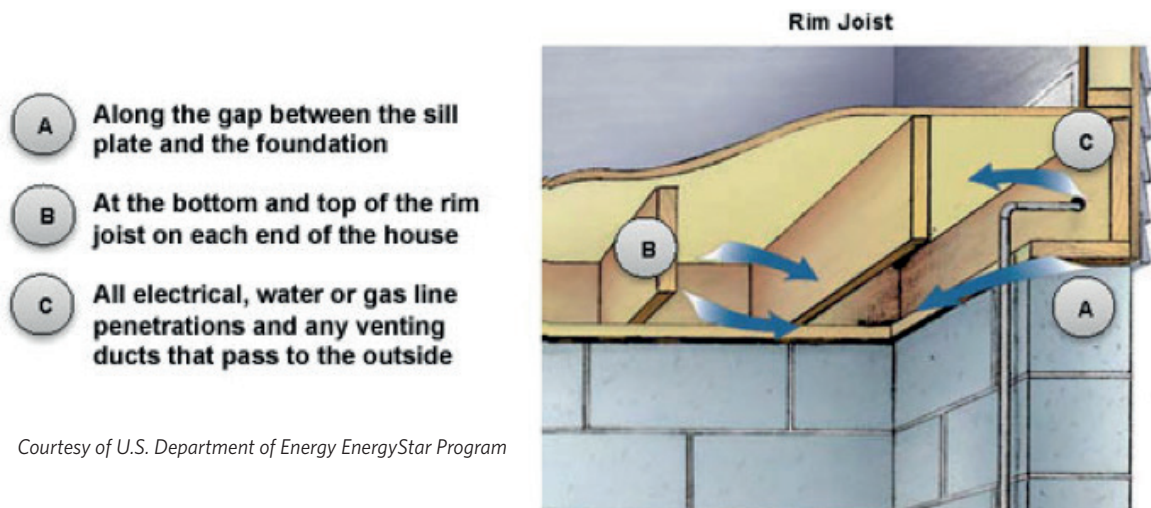
**FIGURE 11.** Air infiltration paths near the building foundation

Recent changes to the model energy codes now call for buildings with increased levels of insulation and significantly reduced air leakage. One of the most significant sources of air leakage in framed buildings where the framing meets the foundation, as shown in Figure 11.

Driven by differential pressure, air infiltration occurs through gaps between the sill plate and foundation, at the bottom and top edges of the rim joists, and through various penetrations for plumbing, wiring and ductwork. In homes built more than about 10-15 years ago, these areas were rarely insulated and almost never properly sealed.

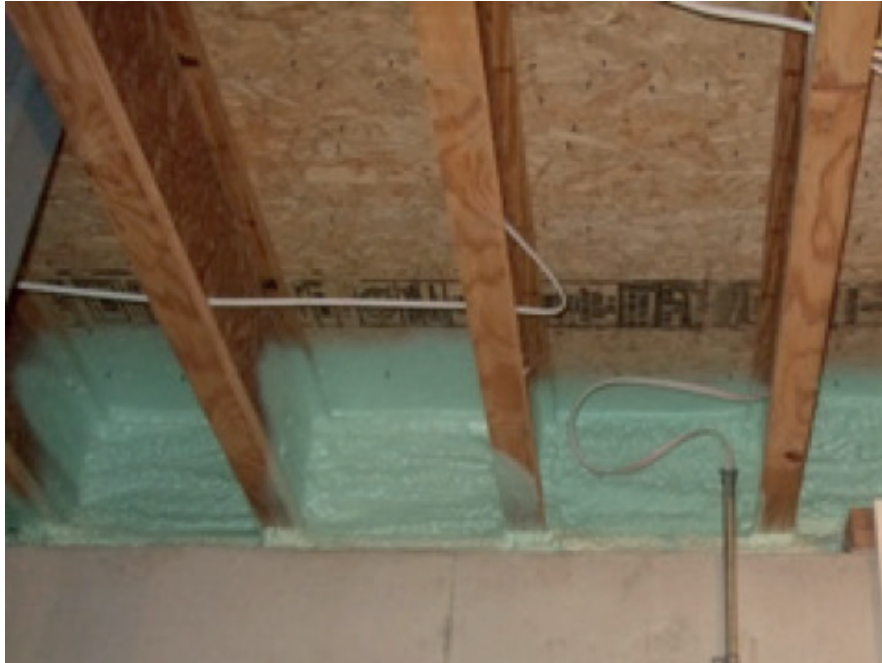
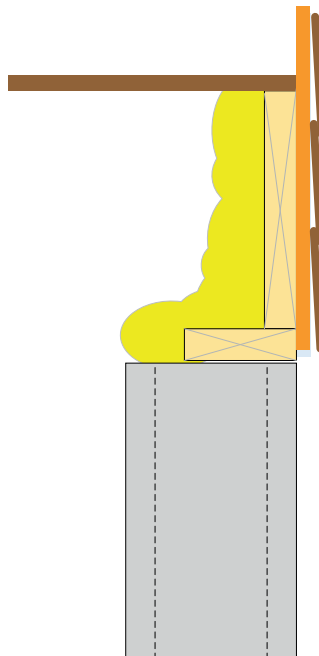
**FIGURE 12.** Closed-cell SPF insulation at the foundation-framing area

SPF is often used by builders of new homes and weatherization contractors in existing homes at the framing-foundation area, and is often regarded as an especially cost-effective and reliable means to insulate and air seal these critical areas\*. Figure 12 shows the installation of closed-cell SPF from beneath the subfloor to the top of the foundation, providing long-lasting insulation, air sealing, and moisture control.

The concern by some pest control and inspection companies with these permanent applications of foam plastic in the rim joist, shown in Figures 12 and 13, is that it does not permit removal of the insulation for traditional visual inspection of the sill plate, band/rim joists or the ends of the floor joists. This challenge can be addressed through use of newer technologies when inspecting for termites.

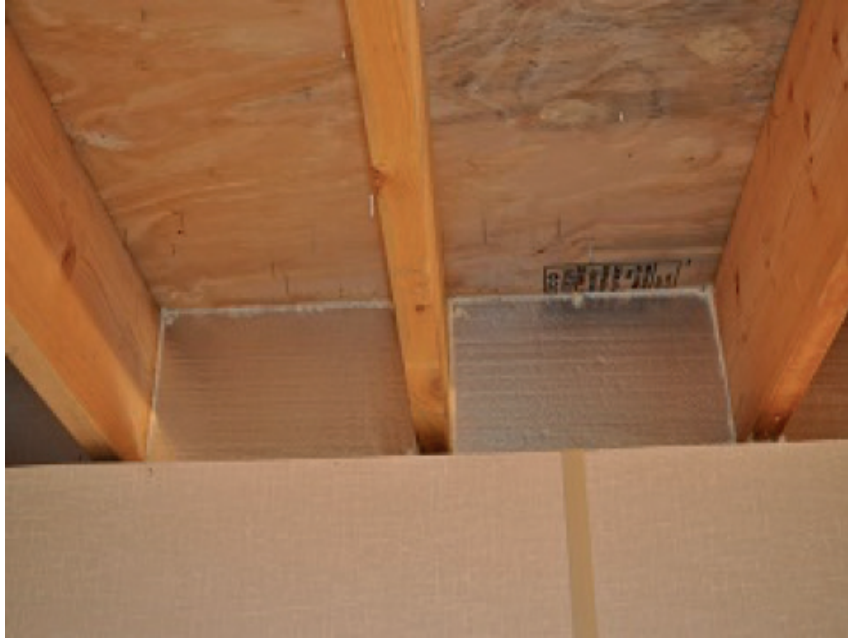
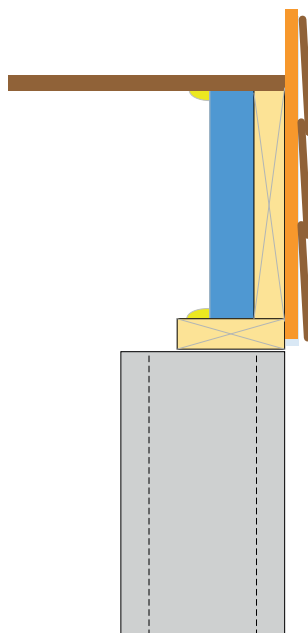
**FIGURE 13.** Foam board insulation and sealant/caulk at the foundation-framing area

Alternative methods of insulating these areas may include the use of cut foam insulation board perimeter sealed with caulk or polyurethane foam sealant, as shown in Figure 13. This approach, is used by some weatherization contractors. It is generally more labor intensive than SPF application, as it requires cutting of the foam board followed by the application of a caulk or sealant. It can be especially difficult application in tight areas and will require cutting around engineered wood I-joists. Like SPF, this application provides long-lasting insulation, air sealing and moisture control. Note that this method does not always provide sealing of the gap between the sill plate and foundation.

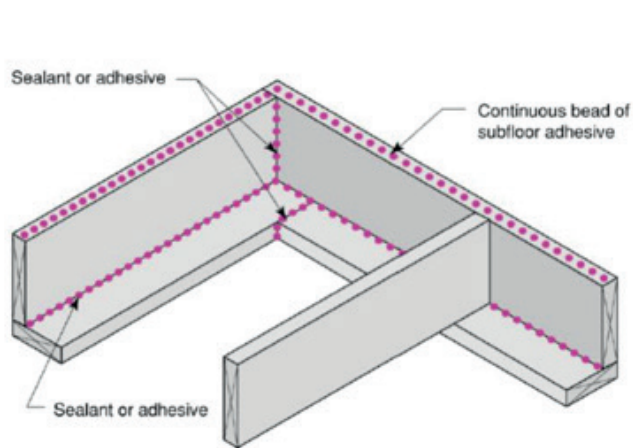
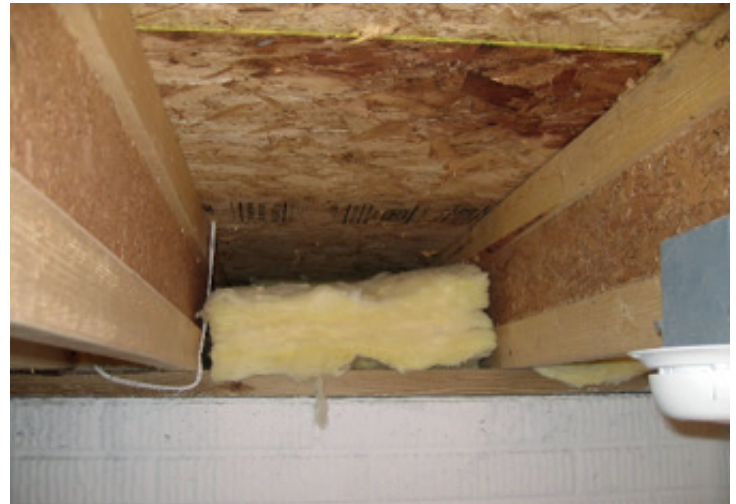
**FIGURE 14.** Sealing and insulating the band joist with fiberglass batts (improperly re-installed)

Another means of insulating and air sealing of the framing near the foundation involves application of a caulk or sealant around the perimeter of each cavity, followed by installation of insulation batts, as shown in Figure 14. Like the use of foam board insulation, it requires a labor-intensive caulking or sealing. It should be noted that unlike SPF and boardstock, this is not a permanent installation.

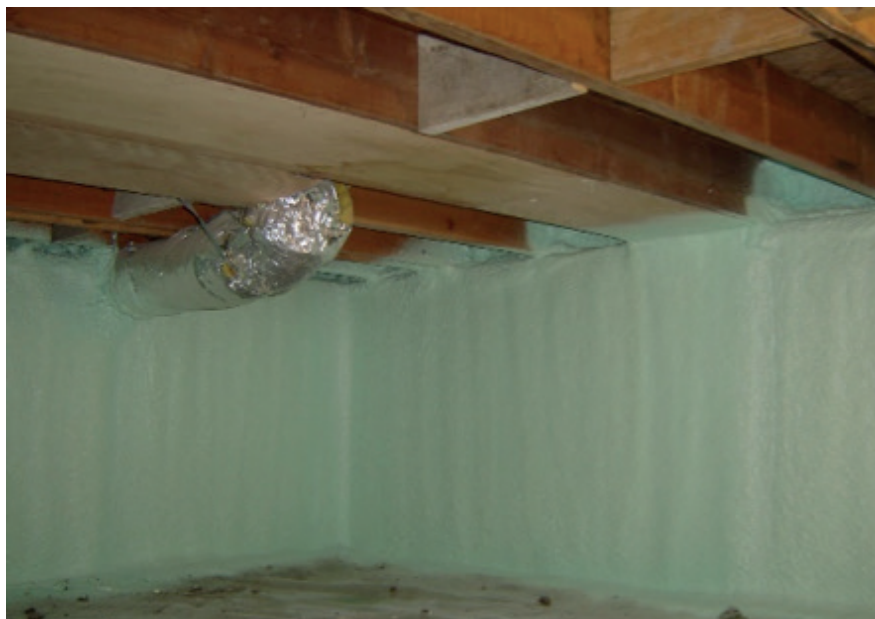
**FIGURE 15.** SPF insulation of a conditioned crawlspace wall

In some buildings, the SPF application of Figure 13 is extended to insulate conditioned crawlspaces and basements by applying a continuous layer of insulation from the subfloor to the vapor retarder/barrier installed on the floor of the crawlspace or to the slab in the basement, shown in Figure 15.

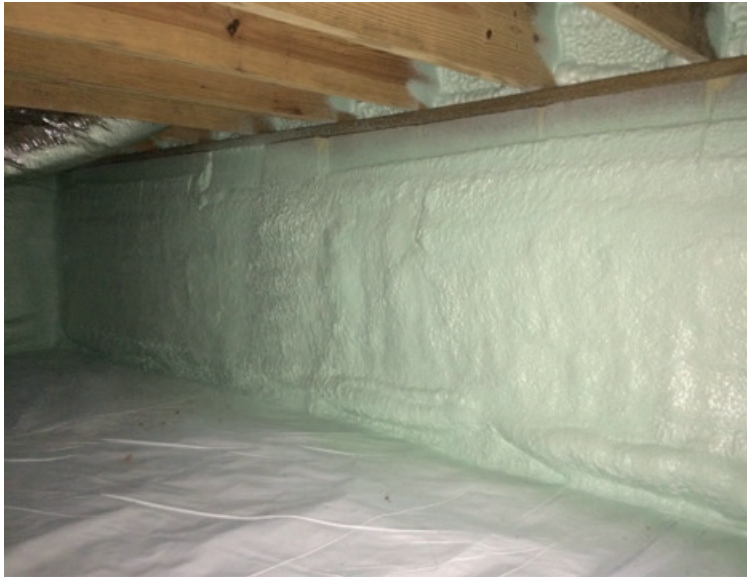
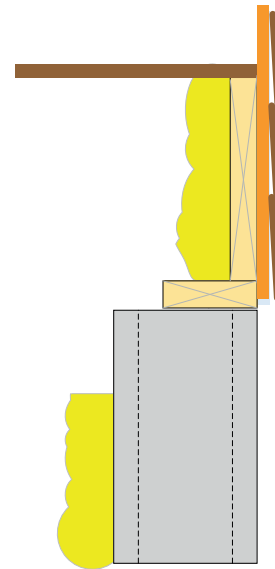
**FIGURE 16. Installation of SPF to provide termite inspection strip**

In addition, some states including North Carolina<sup>xi</sup>, Georgia<sup>xii</sup> and Alabama<sup>xiii</sup> have modified the model code to include a termite inspection strip above and below the top of the foundation wall to expose the sill plate and lower band/rim joist for visual inspection. SPF can be installed in this manner to meet these state-specific codes, as shown in Figure 16.

It should be noted that the SPF installation of Figure 16, while sealing some air leakage paths and meeting certain code requirements for termite inspection strips, does not seal the path between the sill plate and foundation, and caulking may be needed at this location to enhance the air leakage resistance of the sill sealer.

As an alternative to encapsulated or conditioned crawlspaces, with the interior of the stem walls covered in foam as shown in Figure 16, SPF can be applied directly below the subfloor and leaving the crawlspace vented. This installation is shown in Figure 17. While this application will typically require more insulation than a conditioned crawlspace, it enables complete access to the band joist and sill plate areas for termite inspections. Application of SPF to the subfloor will help provide air sealing and insulation of the floor assembly, but can limit access to wiring and plumbing. Insulation may need to be added to ductwork and piping located in the vented, unconditioned crawlspaces. Additionally, a vapor retarder may be needed between the SPF and vented crawlspace to help control moisture condensation in hot-humid climates if open-cell SPF is used.

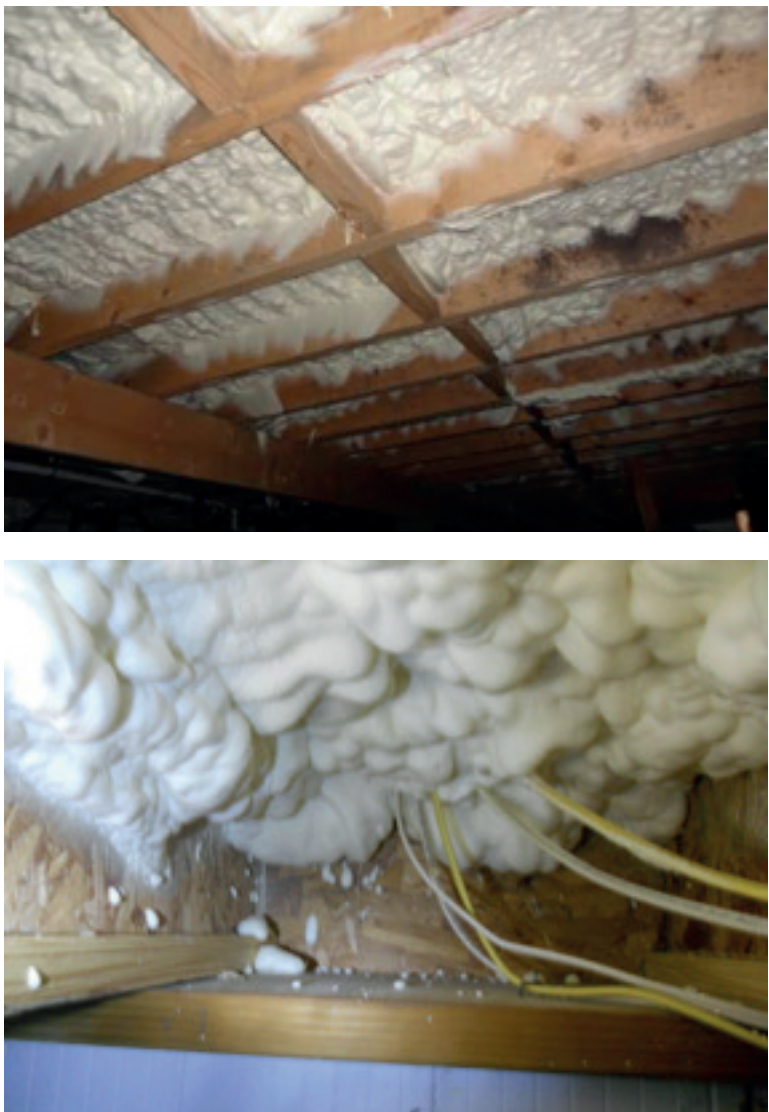
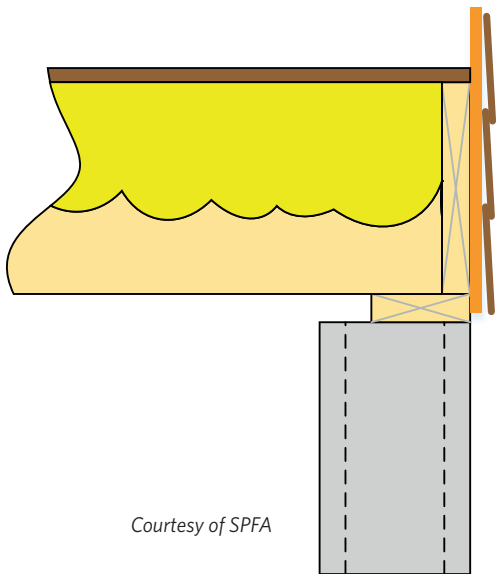
**FIGURE 17.** Installation of SPF below the subfloor allows complete access to the band joist and sill plate for inspection.
